Surface Defect Report (Multi Dents/Bumps)

Project Name	New_Window_Fuselage	Tool Number	040013-dentCHECK2	
Created By		Scan Date	16. Aug 24	Report Date 16. Aug 24
Work Order No.		Flight Hours	[FlightHours]	Registration / Tail No. [Registration]
Carrier	[Carrier]	Flight Cycle	[FlightCycles]	Serial / MSN
Comments

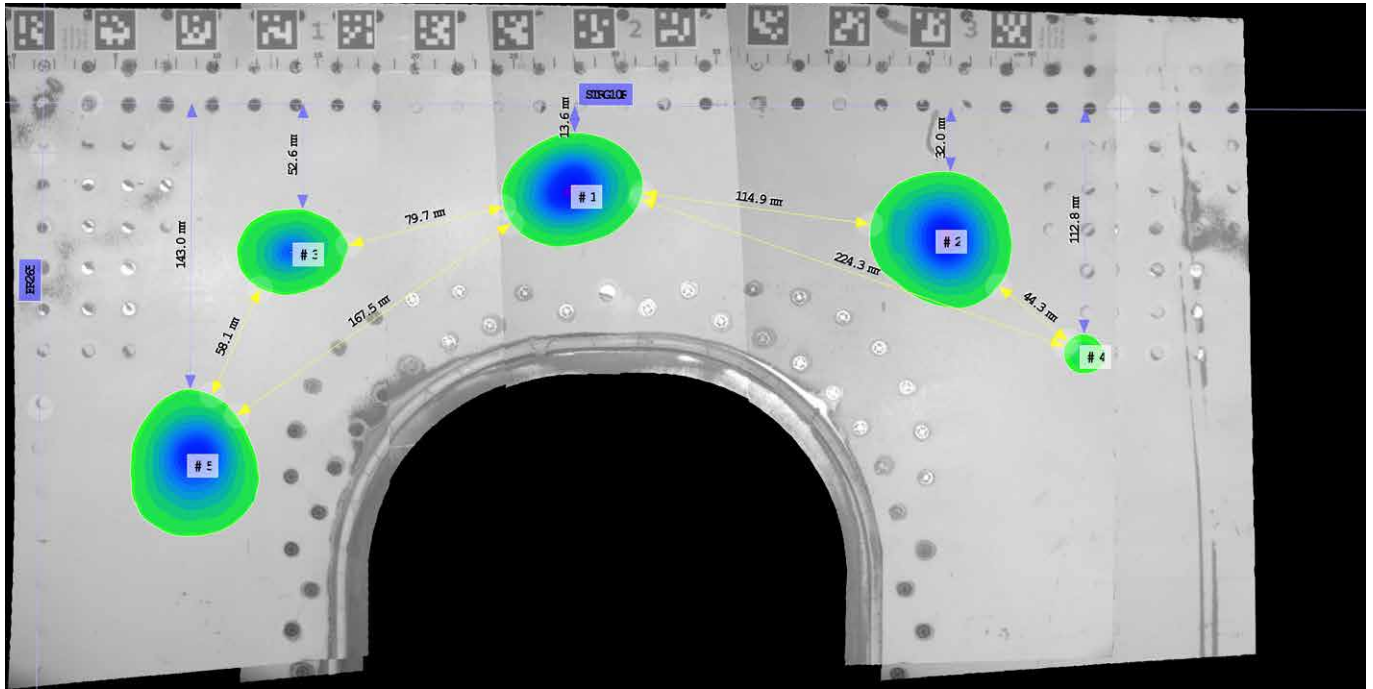
3D Dent Map of Inspected Area

ID	Defect	Deviation	Small Diameter	Big Diameter	Ratio	STRG10R - A Dist.	STRG10R - B Dist.	FR265 - A Dist.	FR265 - B Dist.	Closest Dent ID	Distance
1	Dent	-0.80	55.8	71.0	70	43.6	13.6	264.0	229.8	3	79.7
2	Dent	-0.90	66.1	73.1	73	65.4	32.0	452.6	414.0	4	44.3
3	Dent	-0.44	42.7	55.4	97	74.2	52.6	123.8	97.6	5	58.1
4	Dent	-0.11	19.4	21.3	176	122.6	112.8	519.2	511.8	2	44.3
5	Dent	-0.69	64.5	73.8	93	175.6	143.0	79.0	45.6	3	58.1
